Alex Sinclair – Marine Consultant

Technical Note – December 2006

‘Thermal Fracture’

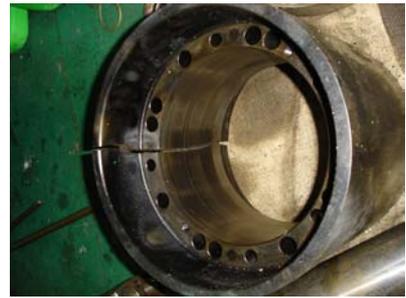
Figure 2 - Severe fracture of piston skirt caused by thermal hoop stress.

Thermal cracks are also discovered in engine pistons, cylinder liners and cylinder heads. Here, they are most often caused by ‘thermal fatigue’. Cyclical heating and cooling repeats, possibly many times, the simple one-off process normally responsible for crankshaft cracks.

The levels of thermal stress generated are potentially more severe than the mechanical operating stresses but in common with repetitive mechanical stress, each cooling part of the thermal cycle induces tensile load. Repeated tensile load is responsible for the initiation and propagation of fatigue cracking. In deciding whether, for example, a cylinder liner has been fractured by thermal or mechanical stress it is instructive to take note of the orientation of fracture. As with the crankshaft, thermal fracture only occurs when metal sections are constrained against shrinkage as they cool from a high to a low temperature. The direction of the stresses, and therefore of fractures, are decided by the directions in which constraint is possible. In the case of a cylindrical cylinder liner constraint is only possible in the circumferential sense, not linear. Therefore, as cracks always form perpendicular to the line of action of the stress causing them, thermal cracks in a cylinder liner are generally orientated axially. Careful consideration of the component geometry is required to diagnose more complex shapes such as cylinder heads.
